**Flood Control Project Maintenance
Levee Inspections**

Fall 2019 Levee Maintenance Deficiency Summary Report

**Flood Control Project Maintenance
Levee Inspections****LMA District Cover Sheet****Fall 2019 Levee Inspection Results****Reclamation District No. 0341 Sherman Island**

Reclamation District No. 0341 Sherman Island

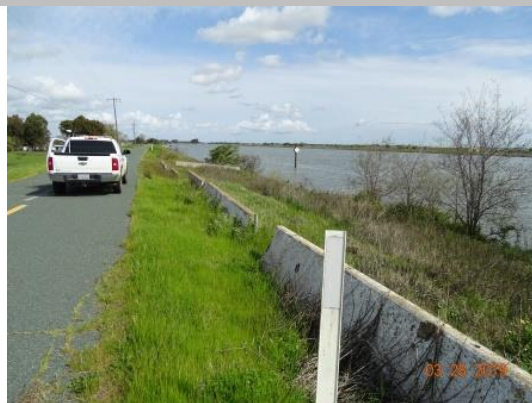
Photo 1 of 1 : FA_2019_RD0341_167_30_20190826_00007.jpg

View looking upstream at K-rail on the waterside shoulder. K-rail keeping vehicle traffic off of survey location. (Spring 2019)

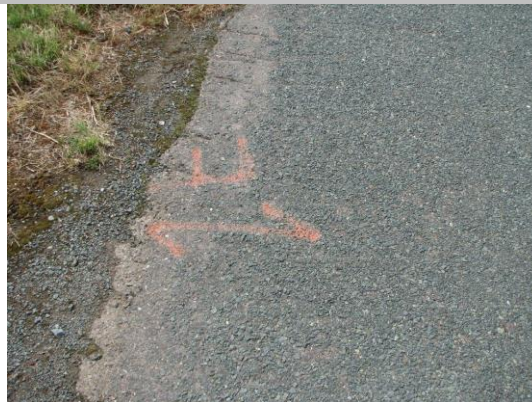
Photo 2 of 3 : UCIP_FA_2019_52253_37646.jpg

Underground Service Alert (USA) markings on road shoulder.

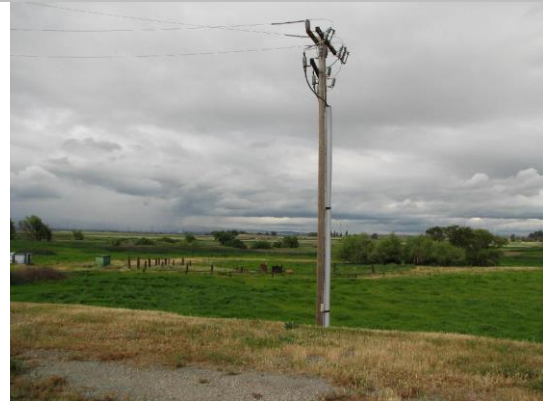
Photo 3 of 3 : UCIP_FA_2019_52253_37645.jpg

Power pole located on LS aligns with crossing.

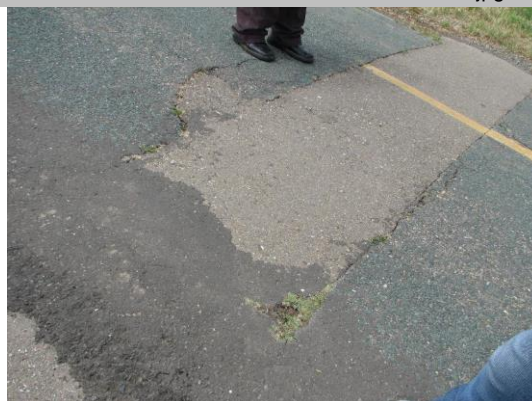
Photo 1 of 3 : UCIP_FA_2019_52254_37654.jpg

Cut along pipe alignment--unknown repair or maintenance date.

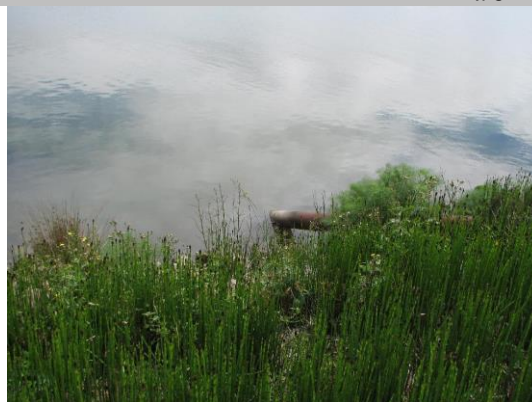
Photo 2 of 3 : UCIP_FA_2019_52254_37658.jpg

Pipe visible from WS.

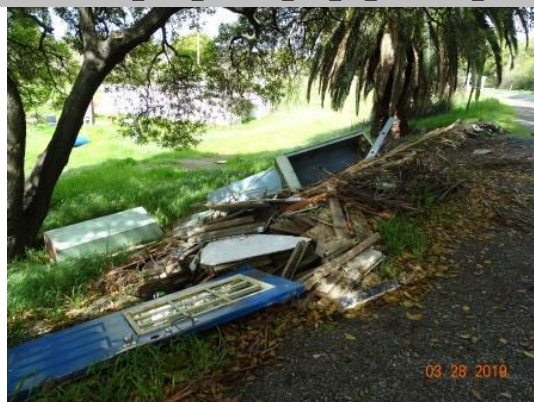
Photo 1 of 1 : FA_2019_RD0341_167_33_20190826_00009.jpg

LM Start	1.96	Rating **	M	Issue No.	33
LM End	1.96	Issue Type +	Ma	Location *	LS
Category	Earthen Levee			GPS Latitude/Longitude	
				Start	End
Item	Encroachments			38.113663 °	38.113663 °
				-121.684131 °	-121.684131 °
DWR ID	DWR_RD0341_01_s_2019_33				
Comment Code					
GA : Garbage					
Inspector Comment					
Remove garbage from landside slope.

View looking upstream at garbage pile on the landside slope (Spring 2019).

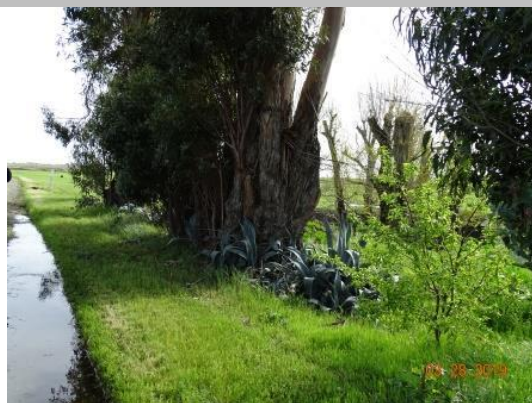
Photo 1 of 1 : FA_2019_RD0341_167_27_20190826_00006.jpg

View looking downstream at cactus on the landside slope (Spring 2019).

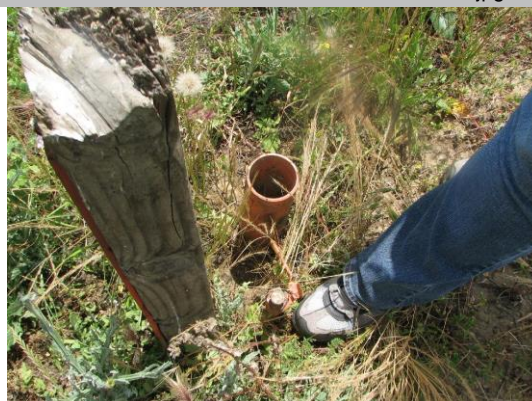
Photo 2 of 3 : UCIP_FA_2019_52265_37747.jpg

Small stand pipe (primer) located on LS--unknown purpose of stand pipe.

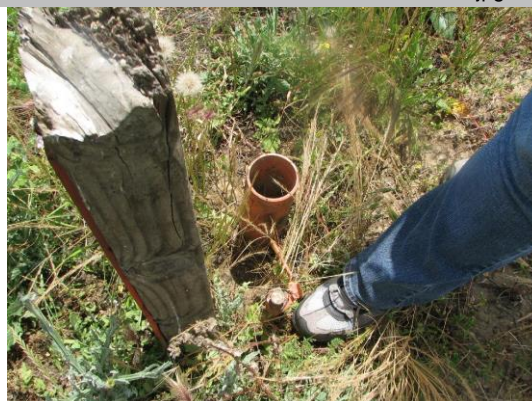
Photo 2 of 3 : UCIP_FA_2019_52266_37755.jpg

Small stand pipe (primer) located on LS--unknown purpose of stand pipe.

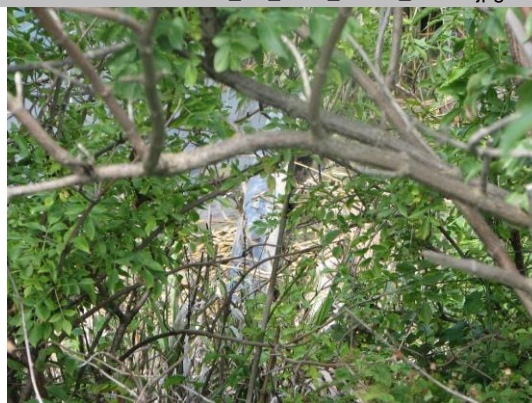
Photo 1 of 3 : UCIP_FA_2019_22203_37833.jpg

Limited access to waterward side--pipe visible through brush.

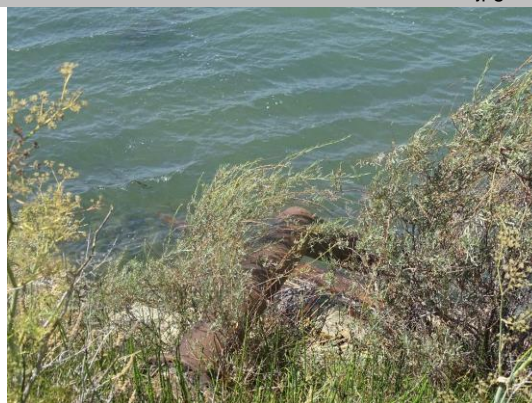
Photo 3 of 3 : UCIP_FA_2019_53343_77900.jpg

WS pipe; thick vegetation made access difficult.

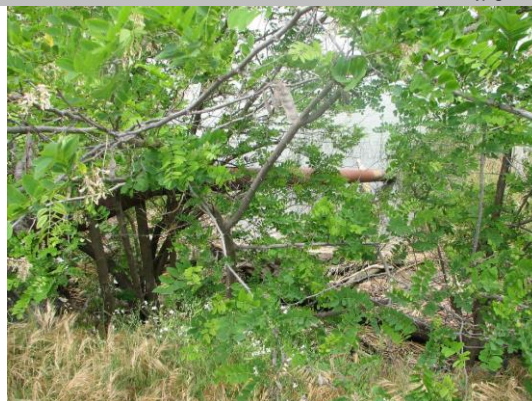
Photo 2 of 3 : UCIP_FA_2019_22256_37914.jpg

View of pipe through brush on waterward side.

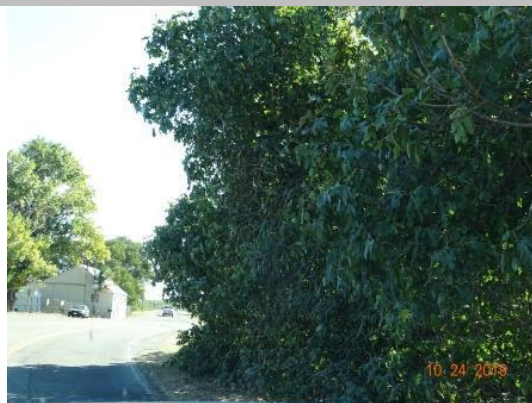
Photo 1 of 1 : FA_2019_RD0341_168_47_20191025_00093.jpg

View looking upstream at fig tree on the landside slope (Fall 2019).

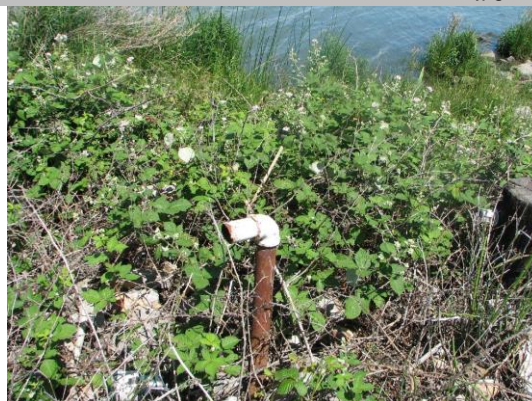
Photo 2 of 2 : UCIP_FA_2019_22262_37952.jpg

View of waterward side air vent pipe could be associated with crossing.

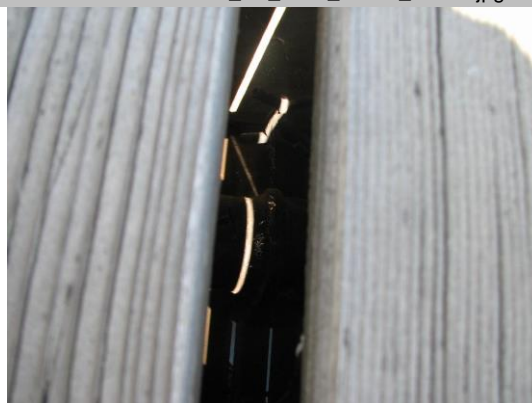
Photo 2 of 3 : UCIP_FA_2019_22263_37961.jpg

Unable to confirm number of pipes.

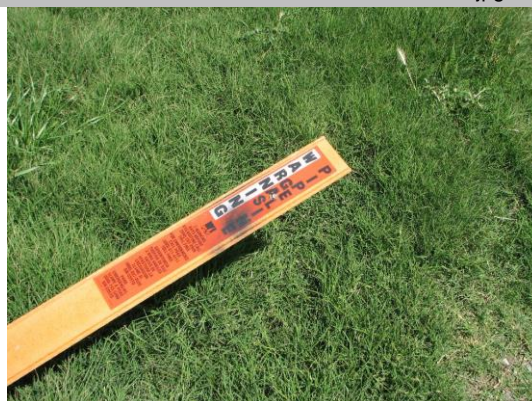
Photo 3 of 3 : UCIP_FA_2019_22263_37960.jpg

Marker damaged on waterward side.

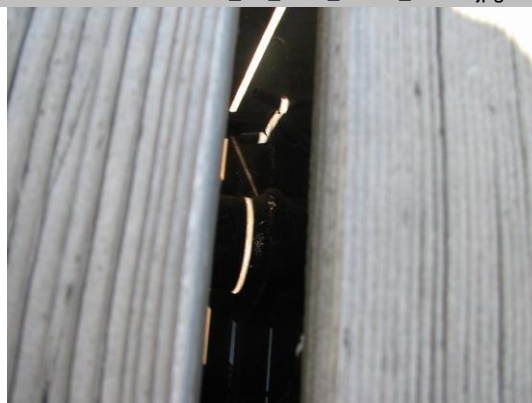
Photo 2 of 3 : UCIP_FA_2019_22264_37964.jpg

Unable to confirm the number of pipe through section of levee.

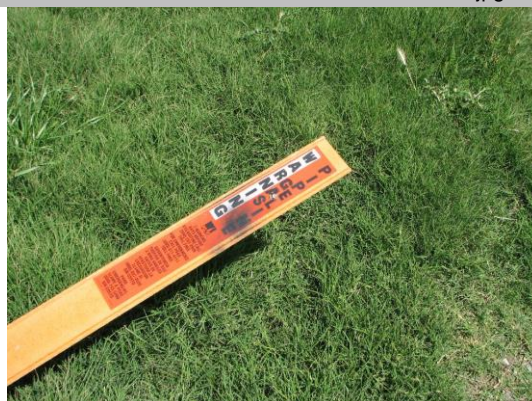
Photo 3 of 3 : UCIP_FA_2019_22264_37963.jpg

Damaged marker located on waterward side.

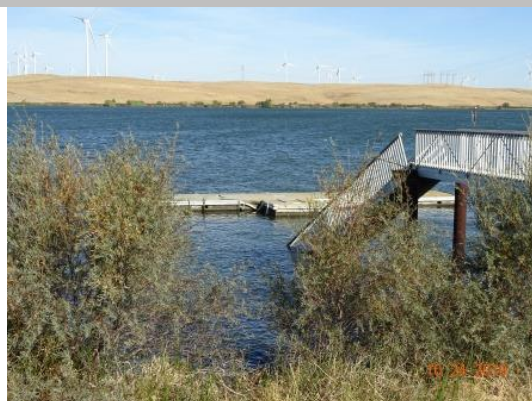
Photo 1 of 1 : FA_2019_RD0341_168_53_20191025_00089.jpg

View of stairs that are not attached to the boat dock (Fall 2019).

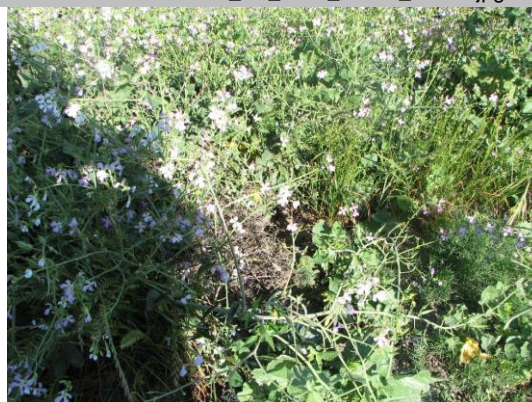
Photo 2 of 3 : UCIP_FA_2019_22324_38095.jpg

Potential subsidence in slope however difficult to determine due to dense vegetation.
